***Seawall Evaluation Report  
Kinnickinnic River, Wisconsin  
Milwaukee Estuary Area of Concern  
Sediment Removal Concept Design***

***Prepared for  
U.S. Army Corps of Engineers  
Detroit District***

***July 2003***

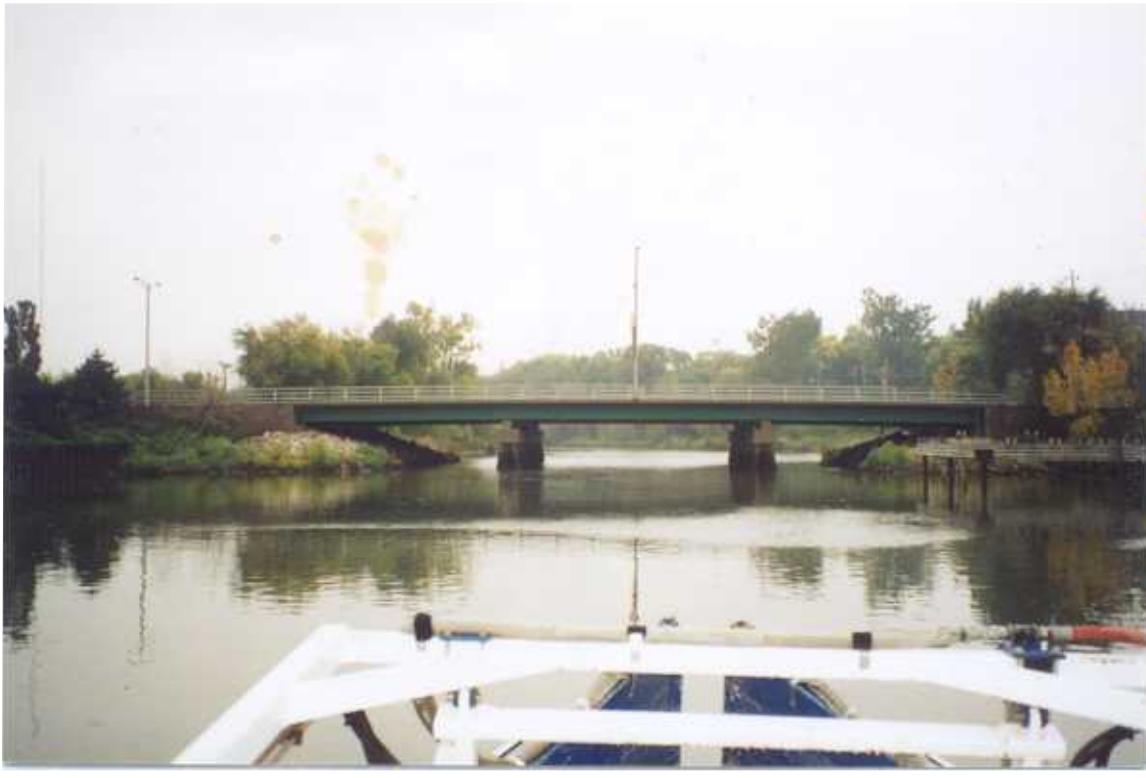
**PHOTO 1 – October 4, 2002 – Kinnickinnic River  
Taken By Tor Hansen, Barr Engineering  
Becher Street Bridge looking upstream (South)**

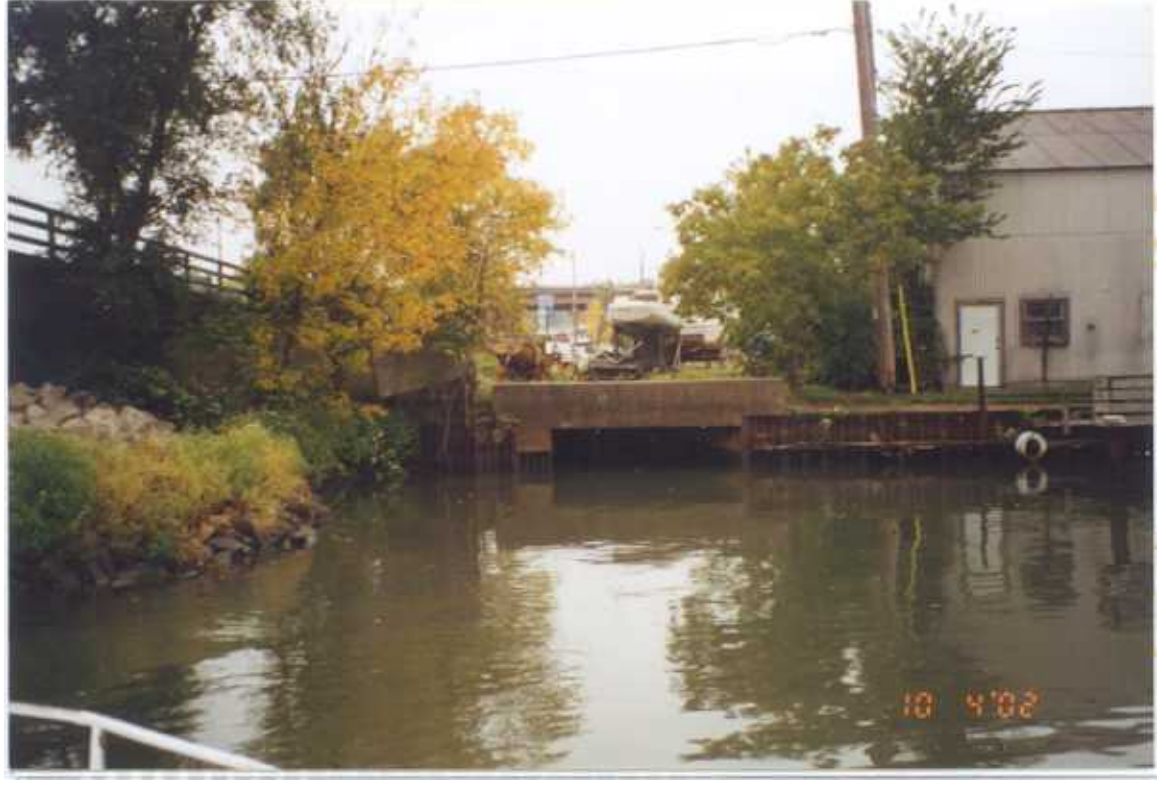
**PHOTO 5 – October 4, 2002 – Kinnickinnic River**  
 Taken by Tor Hansen, Barr Engineering  
 Steel sheet pile wall along Parcel 429. Looking west.

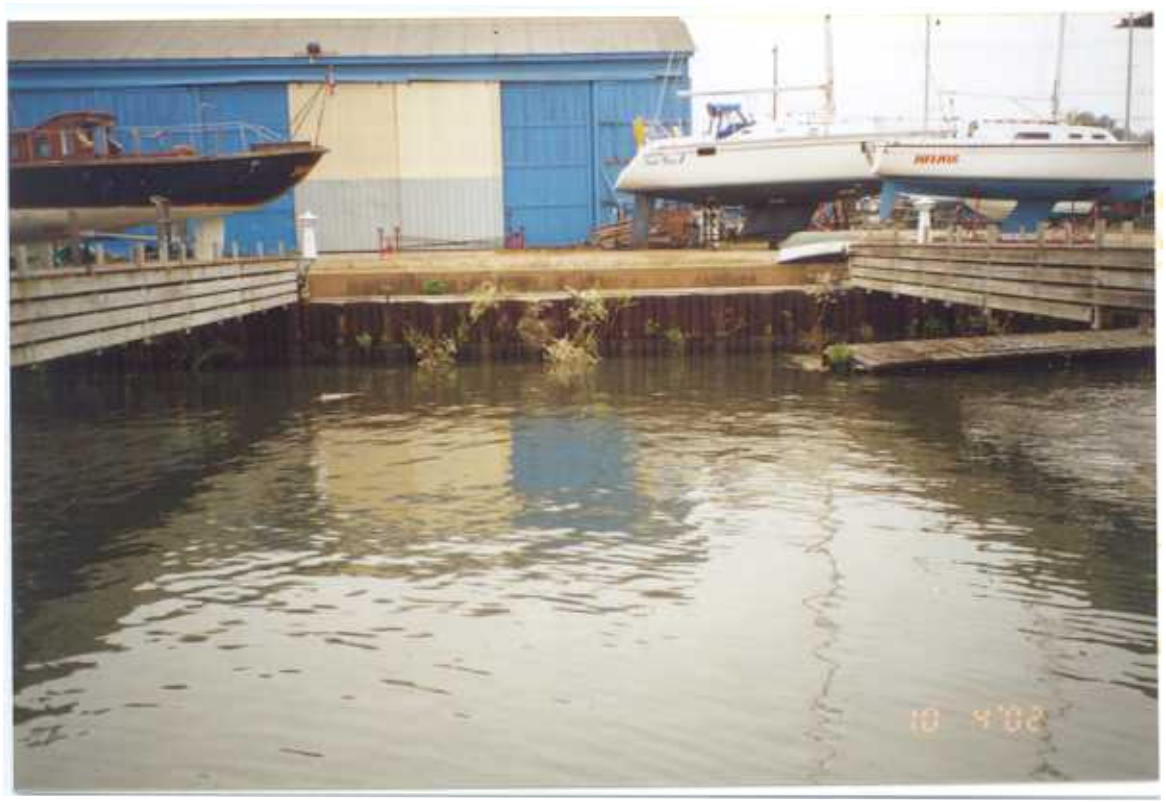
PHOTO 8 – October 4, 2002 – Kinnickinnic River  
Taken by Tor Hansen, Barr Engineering  
Steel sheet pile wall along Parcel 429. Looking west.

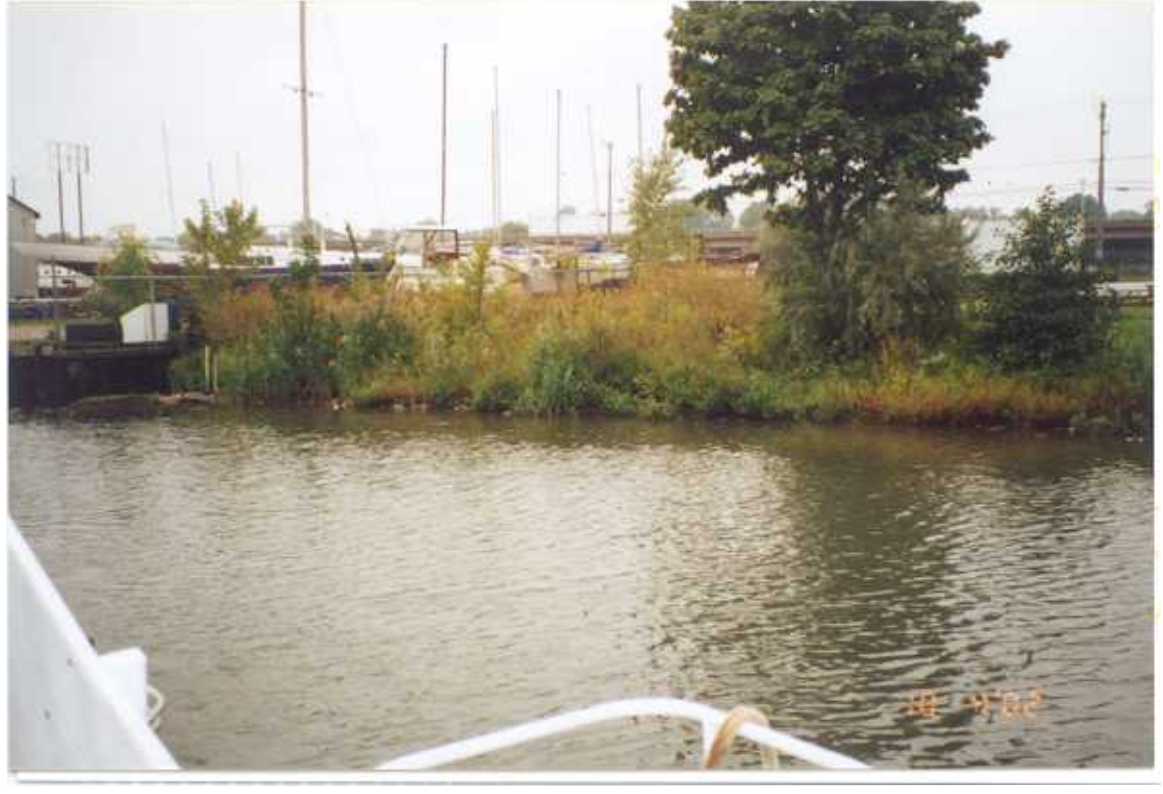
**PHOTO 12 – October 4, 2002 – Kinnickinnic River  
Taken by Tor Hansen, Barr Engineering  
Vegetation at shoreline along Parcel 428. Looking west.**

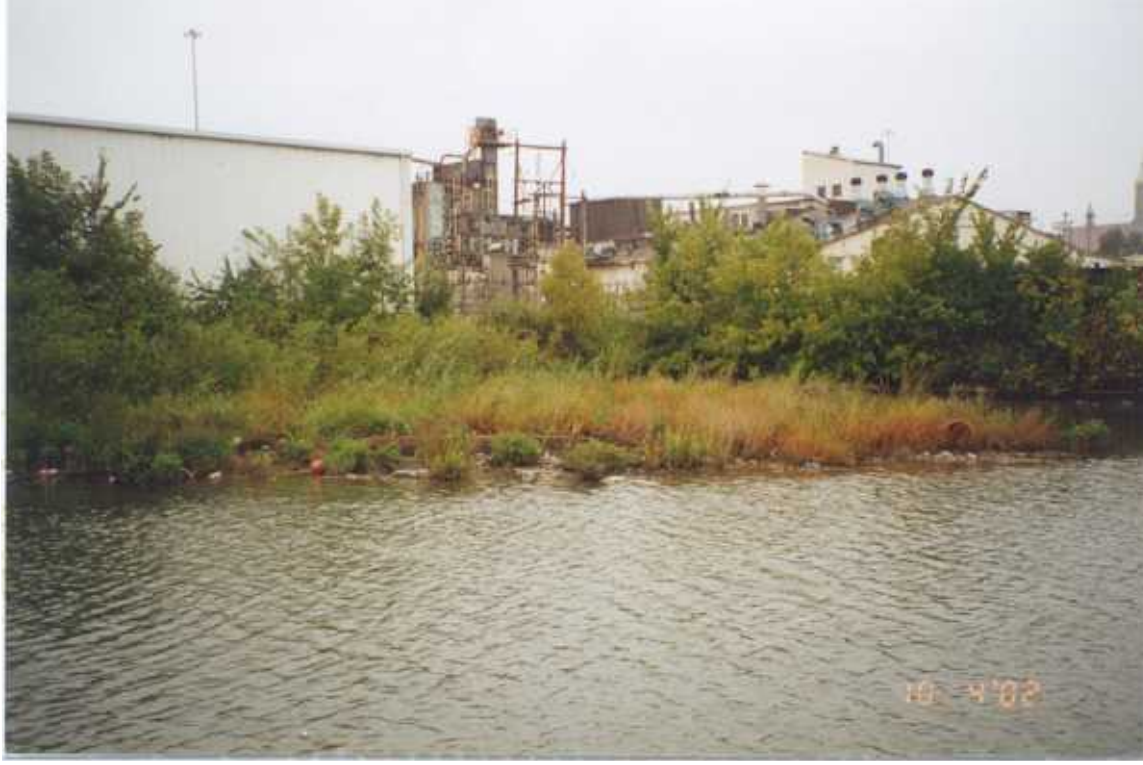
PHOTO 14 – October 4, 2002 – Kinnickinnic River  
Taken by Tor Hansen, Barr Engineering  
Vegetation at shoreline along Parcel 427. Looking west.

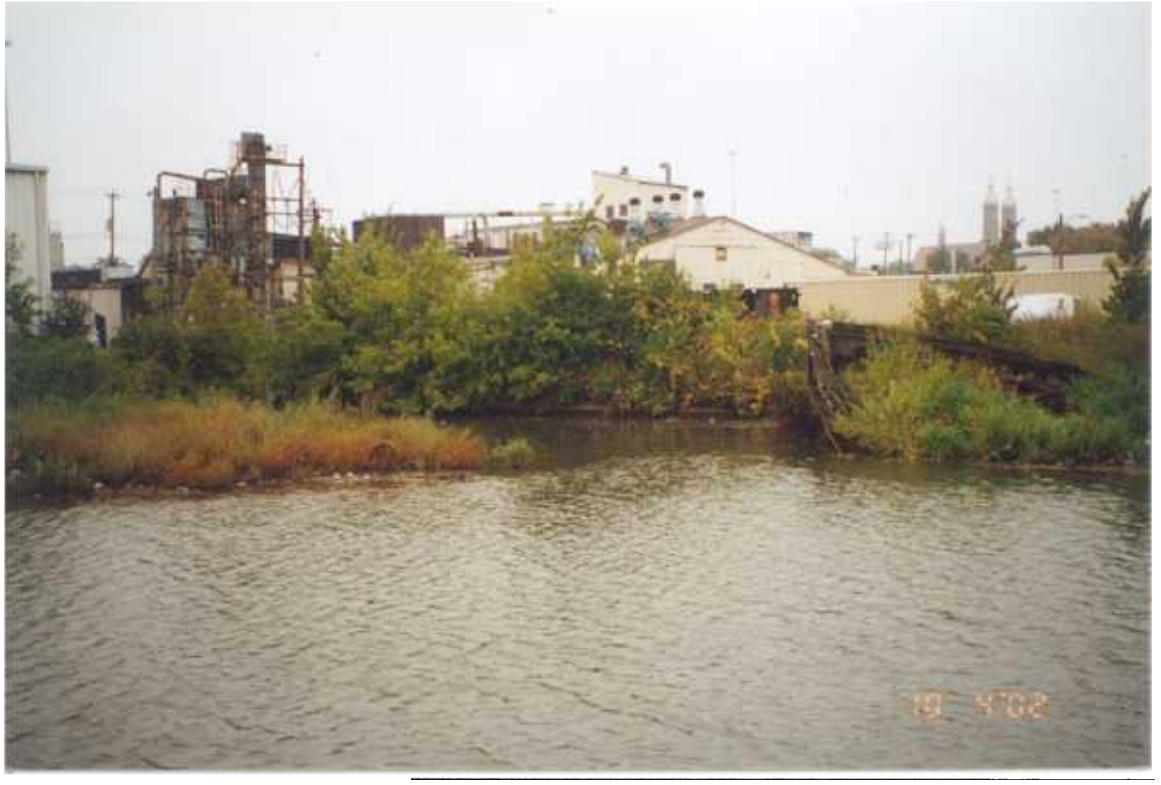
**PHOTO 16 – October 4, 2002 – Kinnickinnic River  
Taken by Tor Hansen, Barr Engineering  
Vegetation at shoreline along Parcel 427. Looking north.**

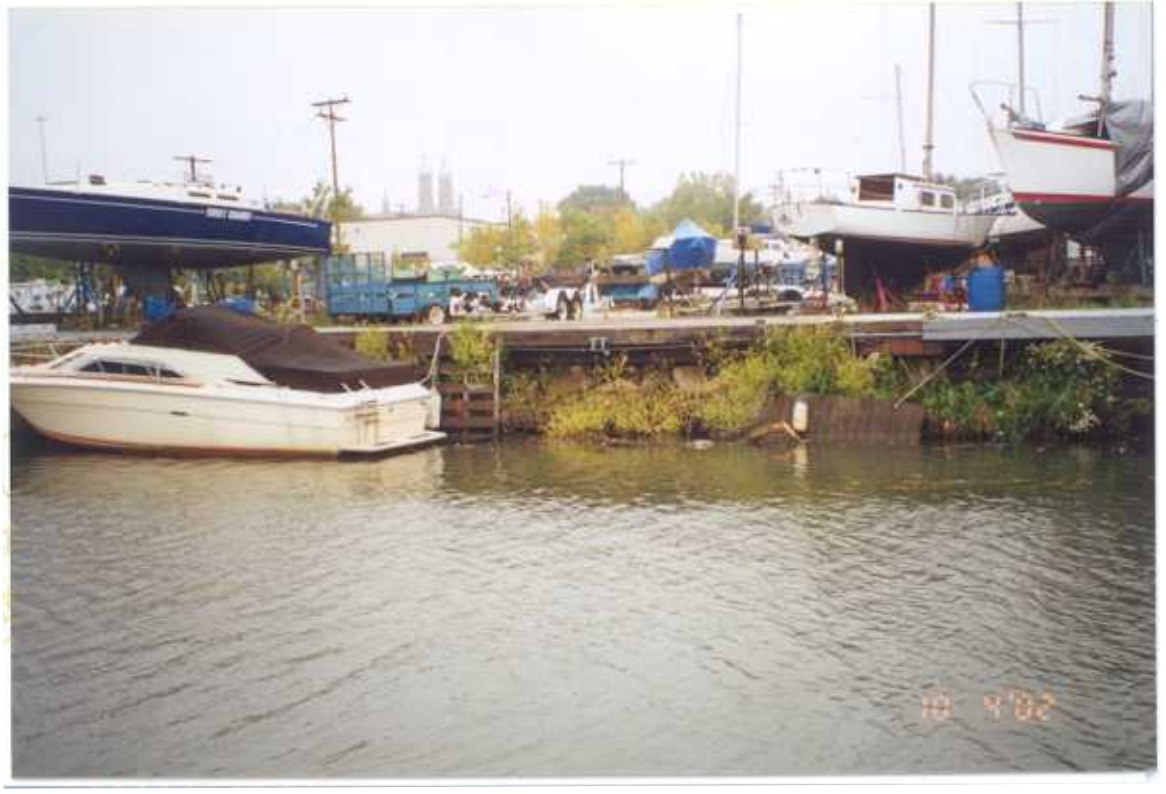
The Wakefield timber walls as shown on records and observed were either in poor condition or no longer in existence. These walls were found on all or portions of Parcels 425, 426A, 426B, 440, 441, 442, and 443. For the walls immediately lining the river in Parcels 425, 426A and 426B, dredging the channel would likely have a negative effect on these walls due to their poor condition, age, and because records indicate they are not embedded as deeply as more recent SSP walls. For the walls either missing or far inland from the river bank as found in Parcels 440 through 443, dredging would not affect these sections of the river bank. Recommendations for stabilizing or strengthening these walls during dredging are included in Section 5.0.

PHOTO 20 – October 4, 2002 – Kinnickinnic River  
Taken by Tor Hansen, Barr Engineering  
Timber dock and wall along Parcel 426B. Looking north.

The Wakefield timber walls are generally in poor condition and should be protected during dredging operations. The recommended means for strengthening these walls is to construct new SSP walls immediately adjacent to the existing timber walls. The new walls would remain in place as permanent structures. Depending on site constraints and loading, the walls could be either anchored or cantilevered SSP walls. The approximate length requiring protection is 450 feet. The new steel SSP sheets will be approximately 40 feet long based on the records for existing SSP walls along this area of the river. At a cost of \$20 per square foot (based on recent bid tabs), this equates to a protection cost of \$360,000. Add in costs for fill material and contingency and the total protection cost is on the order of magnitude of \$500,000. This estimate is preliminary and actual costs will be affected by site conditions, final design, and market conditions.

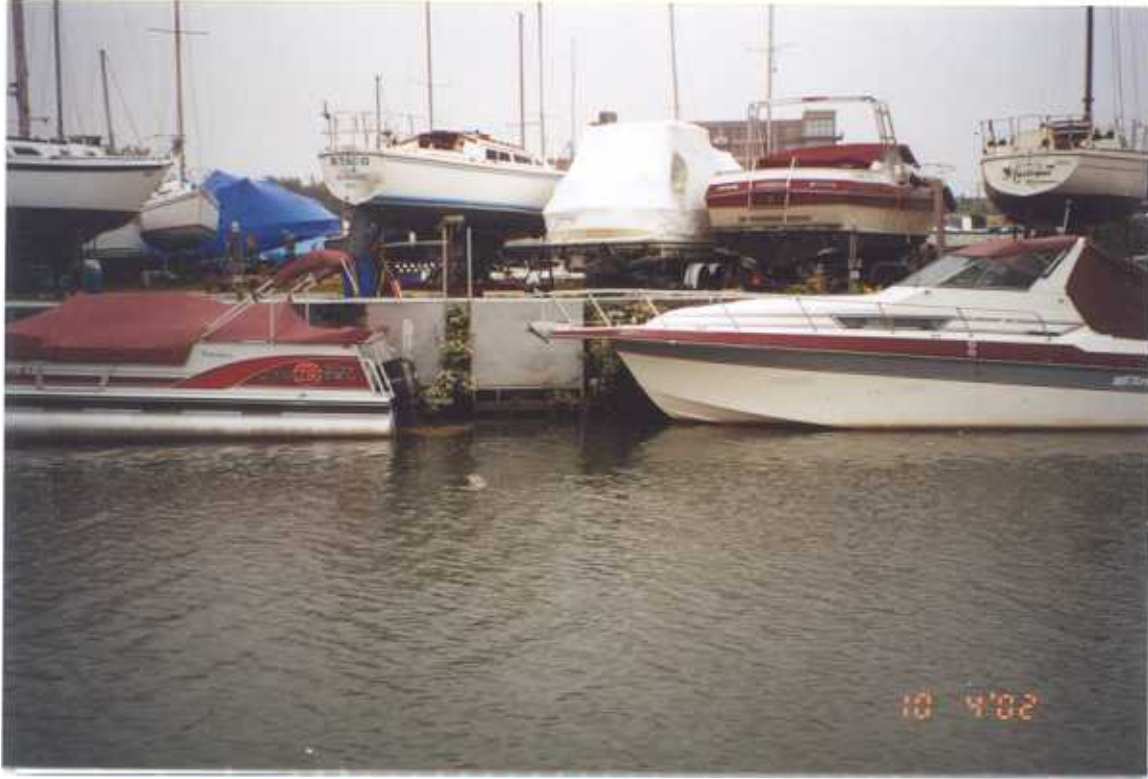
PHOTO 22 – October 4, 2002 – Kinnickinnic River  
Taken by Tor Hansen, Barr Engineering  
Timber dock and wall along Parcel 426B. Looking north.

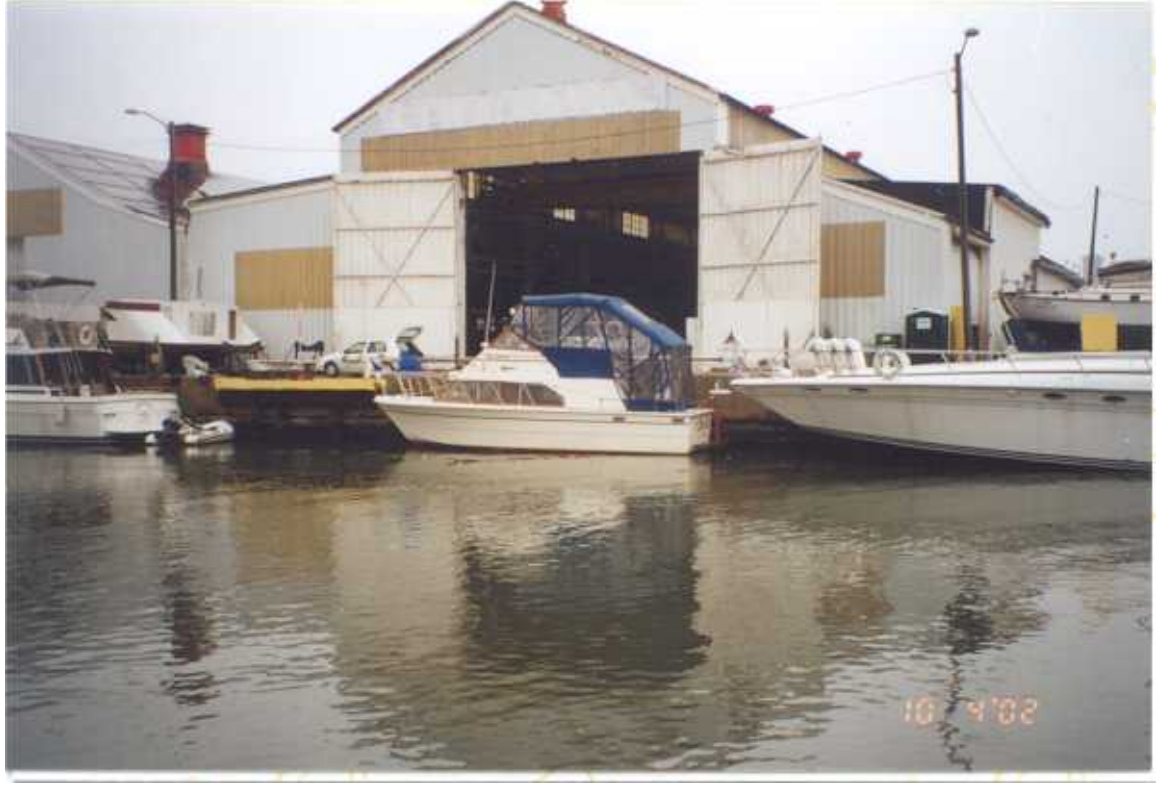
These walls found on Parcels 425, 456A, and 426B were also found to be in poor condition with limited embedment shown on records, and therefore, dredging would likely have a negative effect similar to

**PHOTO 28 – October 4, 2002 – Kinnickinnic River**  
**Taken by Tor Hansen, Barr Engineering**  
**Concrete dock and timber wall at Parcel 426A. Looking north.**

These walls are in poor condition and should be strengthened similarly to the plain Wakefield timber walls. The recommended protection method is the same as mentioned in Paragraph 5.3. The approximate length requiring protection is 535 feet. Using 40-foot sheets at \$20 per square foot, the wall cost is \$428,000. Add costs for fill and contingency and the total protection cost is on the order of magnitude of

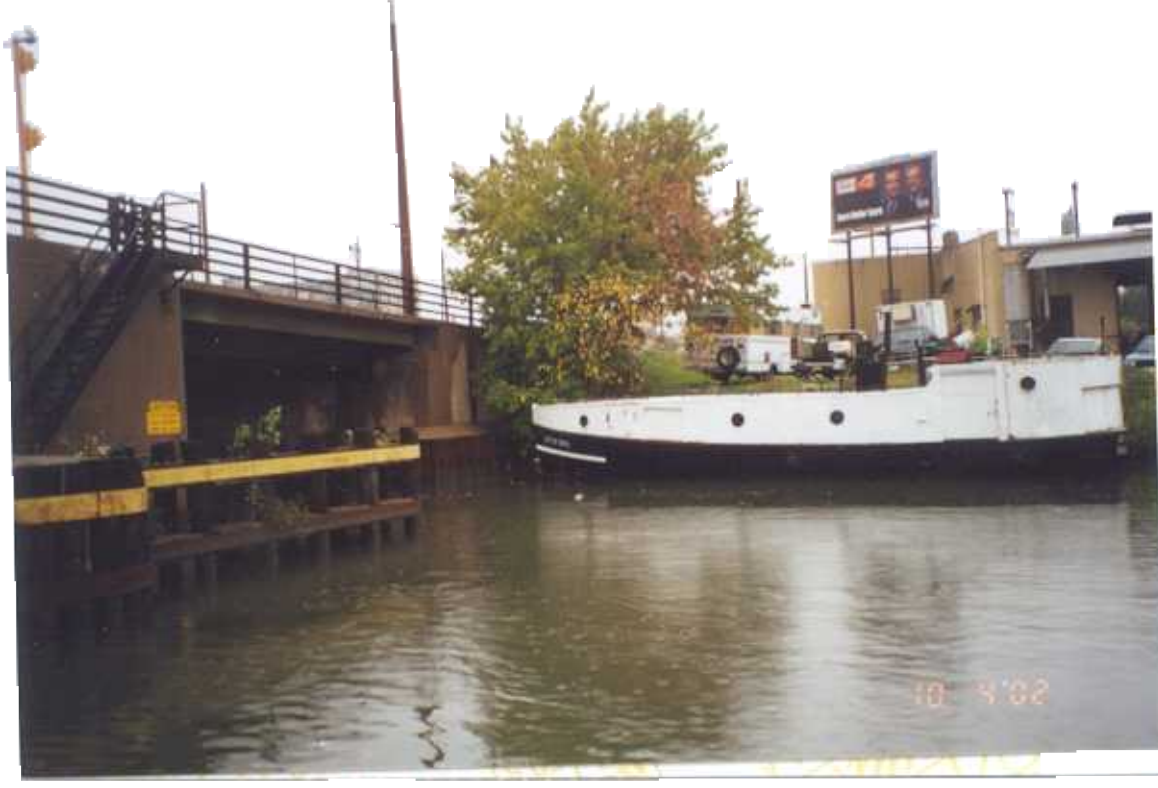
PHOTO 30 – October 4, 2002 – Kinnickinnic River  
Taken by Tor Hansen, Barr Engineering  
Downstream face of pier and left abutment for 1<sup>st</sup> Street Bridge.  
Parcel 426 looking north.

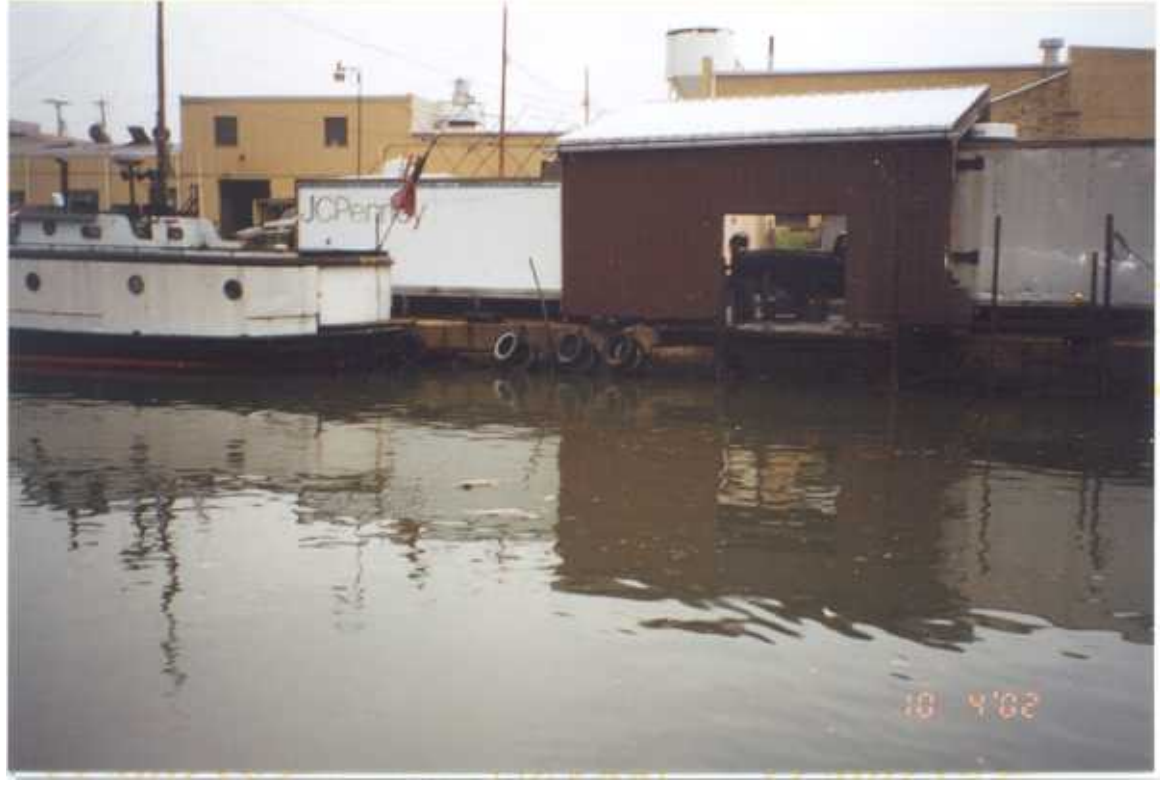
Records for this 693-foot section of the river bank between the 1<sup>st</sup> Street Bridge and the Kinnickinnic Avenue Bridge indicate that no wall exists. However, some portions of this parcel are lined with a timber wall or timber and concrete wall. Roughly 150 feet of this river bank is protected by some sort of timber wall and another roughly 150 feet is protected by a timber and concrete wall. Both sections of wall are in poor condition with rotted wood and spalling concrete at the waterline. The remainder of the river bank within this parcel is unprotected with the river bank contained by vegetation. There is also an old railroad bridge abutment near the downstream end of the parcel just upstream from the Kinnickinnic Avenue Bridge. The abutment is mass concrete and there is some spalling and deterioration of the concrete.

PHOTO 36 – October 4, 2002 – Kinnickinnic River  
Taken by Tor Hansen, Barr Engineering  
Concrete and timber wall along Parcel 425. Looking north.

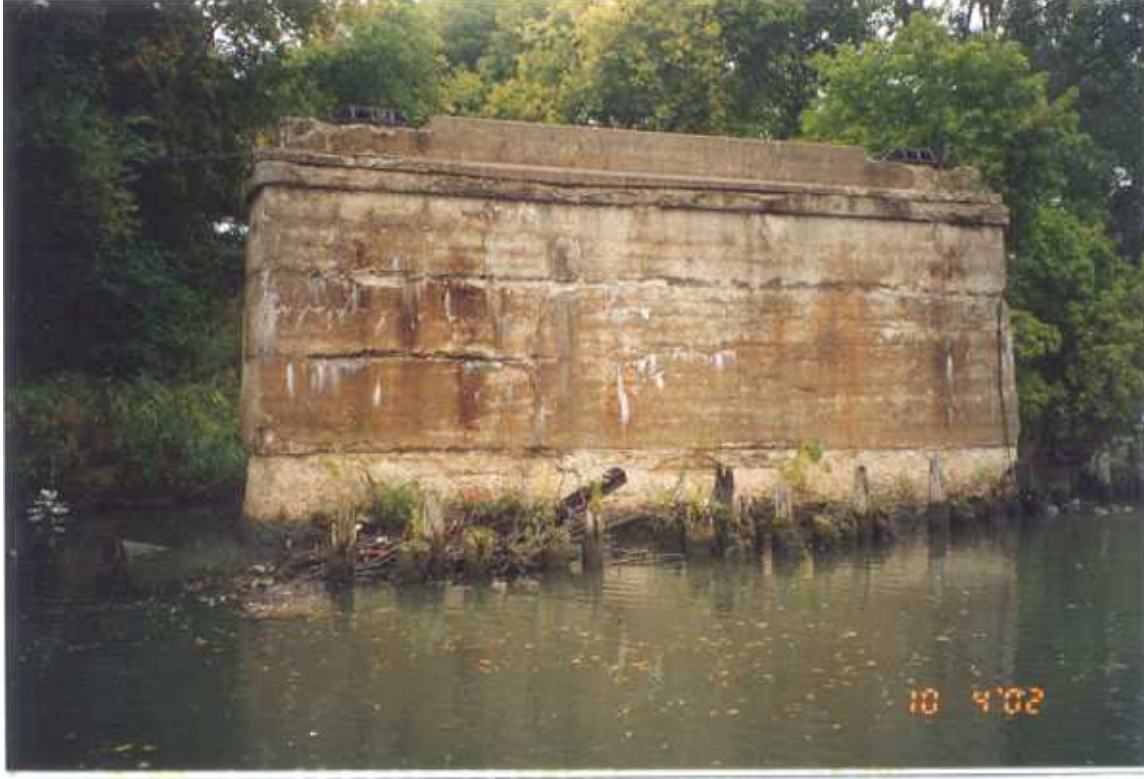
PHOTO 38 – October 4, 2002 – Kinnickinnic River  
Taken by Tor Hansen, Barr Engineering  
Old bridge pier at shoreline along Parcel 425 downstream from  
Photo 37. Looking north.

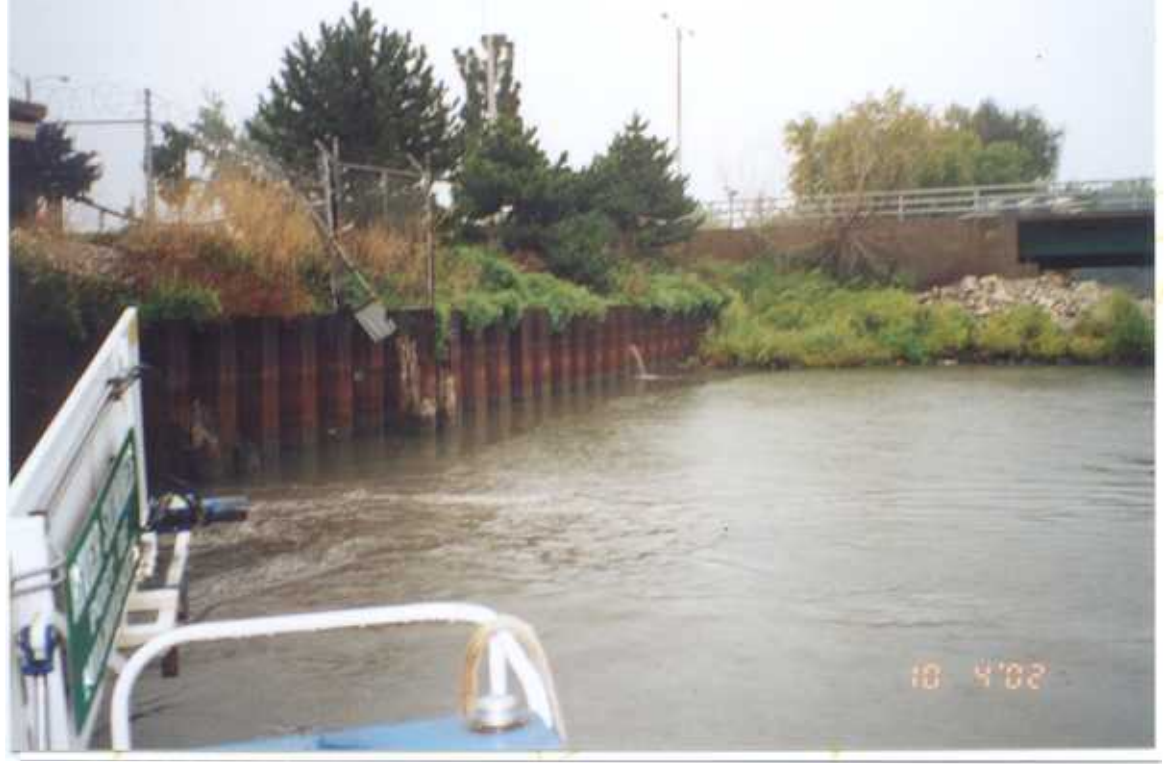
This 556-foot section of the river is lined with an anchored SSP wall constructed in 1969 and 1990. Permits 208-C and 219-C indicate the wall is either 46 feet deep or 25 feet deep. The wall is in good condition with no visible signs of movement or distress. This parcel is adjacent to a bend in the river where the river turns from flowing north to flowing east. 349-feet of the parcel face west and 210-feet face north.

**PHOTO 48 – October 4, 2002 – Kinnickinnic River  
Taken by Tor Hansen, Barr Engineering  
Steel sheet pile wall along Parcel 433. Looking east.**

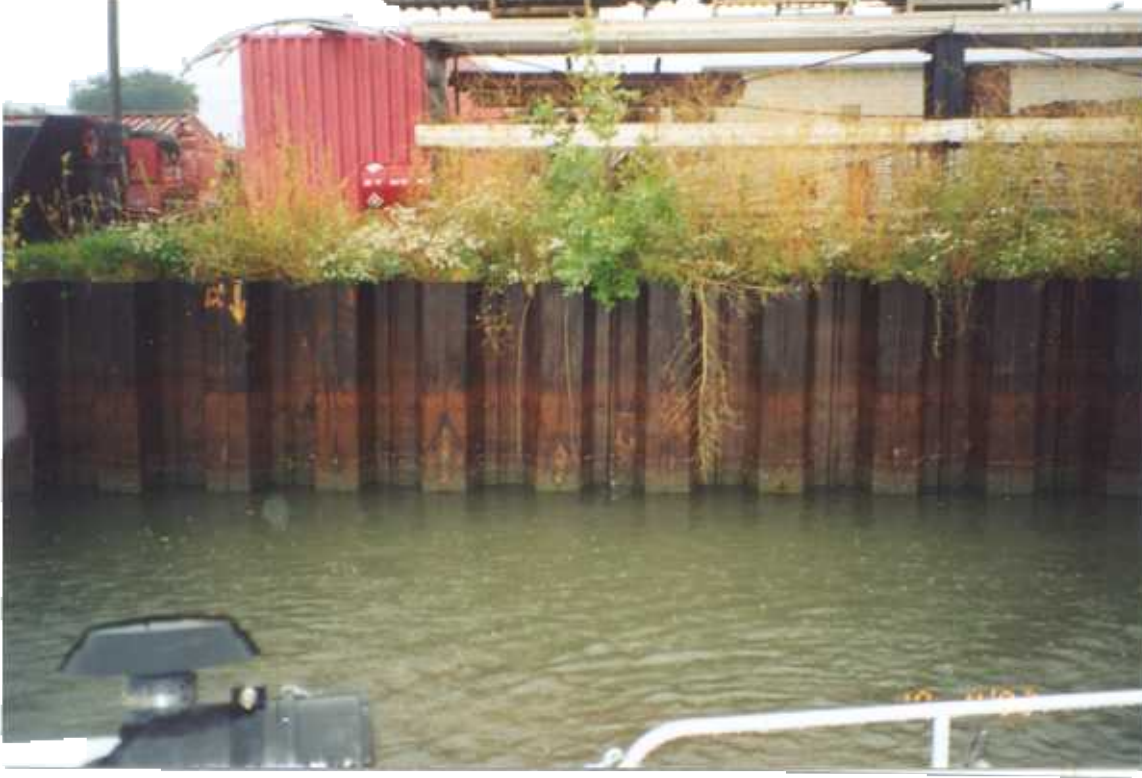
PHOTO 50 – October 4, 2002 – Kinnickinnic River  
Taken by Tor Hansen, Barr Engineering  
Steel sheet pile wall along Parcel 433. Looking east.

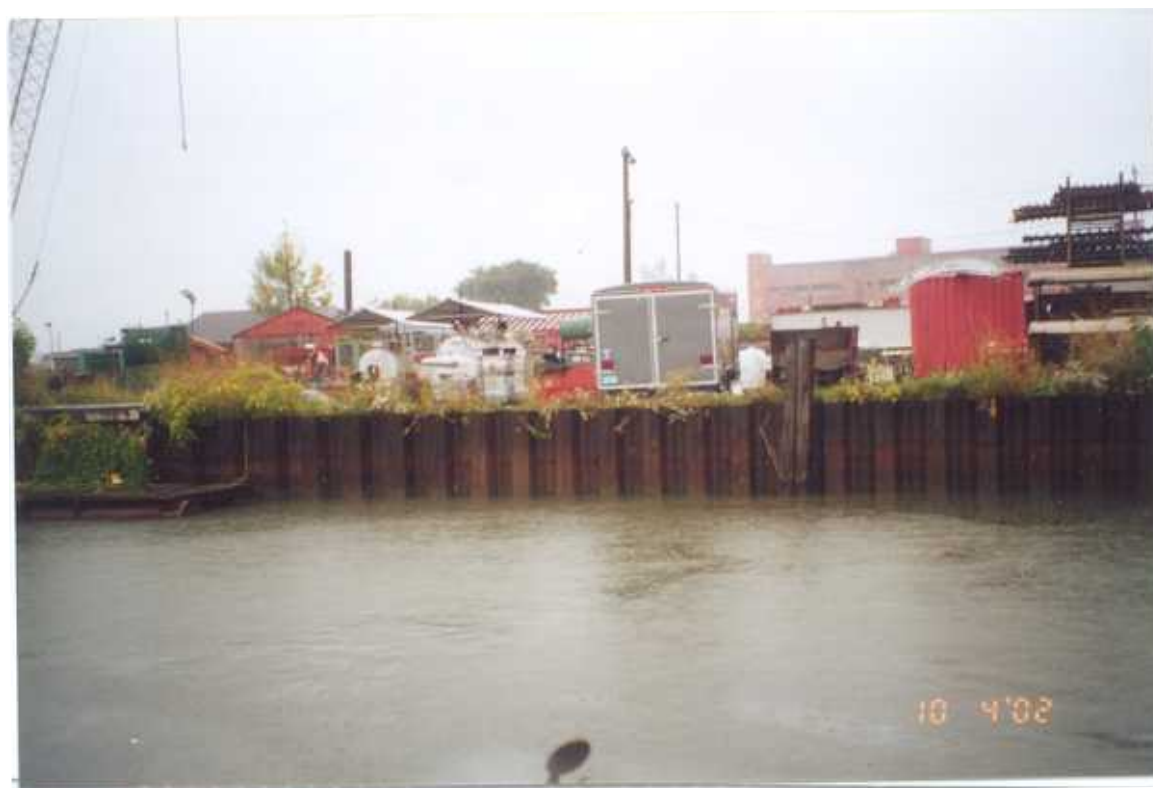
PHOTO 52 – October 4, 2002 – Kinnickinnic River  
Taken by Tor Hansen, Barr Engineering  
Steel sheet pile wall along Parcel 433. Looking east.

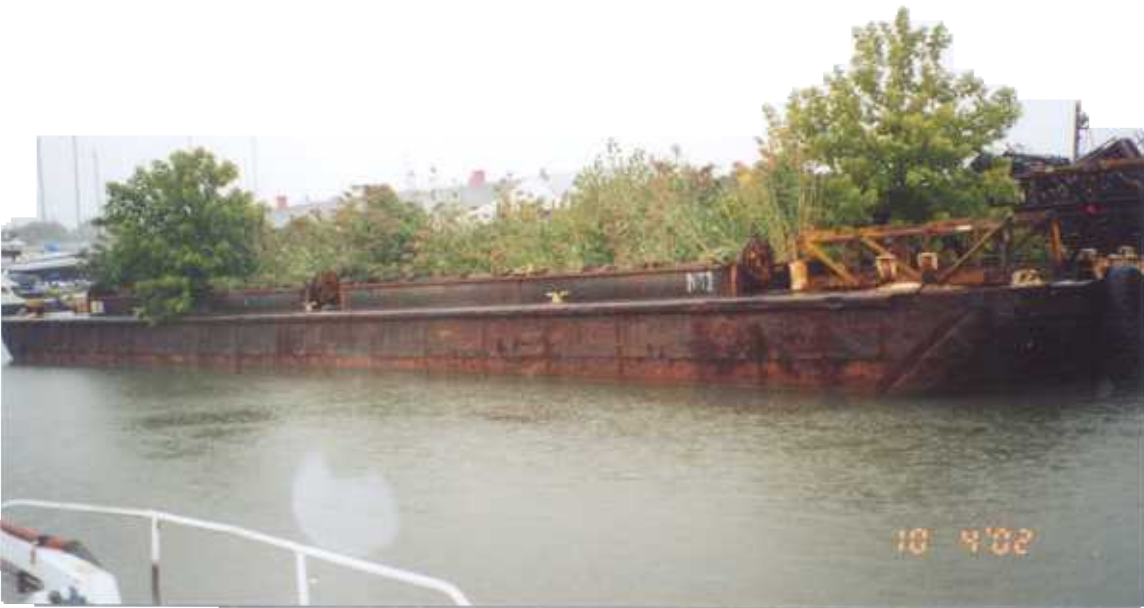
PHOTO 54 – October 4, 2002 – Kinnickinnic River  
Taken by Tor Hansen, Barr Engineering  
Barge in front of steel sheet pile wall along Parcel 433. Looking east.

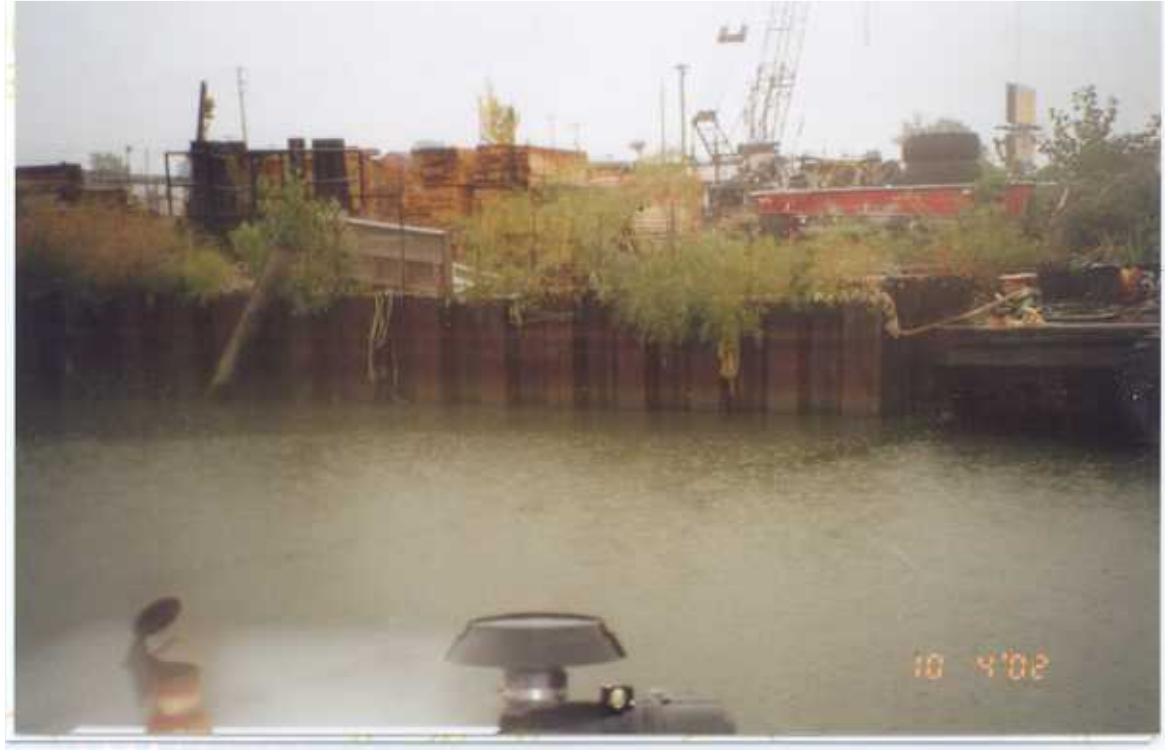
PHOTO 56 – October 4, 2002 – Kinnickinnic River  
Taken by Tor Hansen, Barr Engineering  
Steel sheet pile wall along Parcel 433. Looking south.

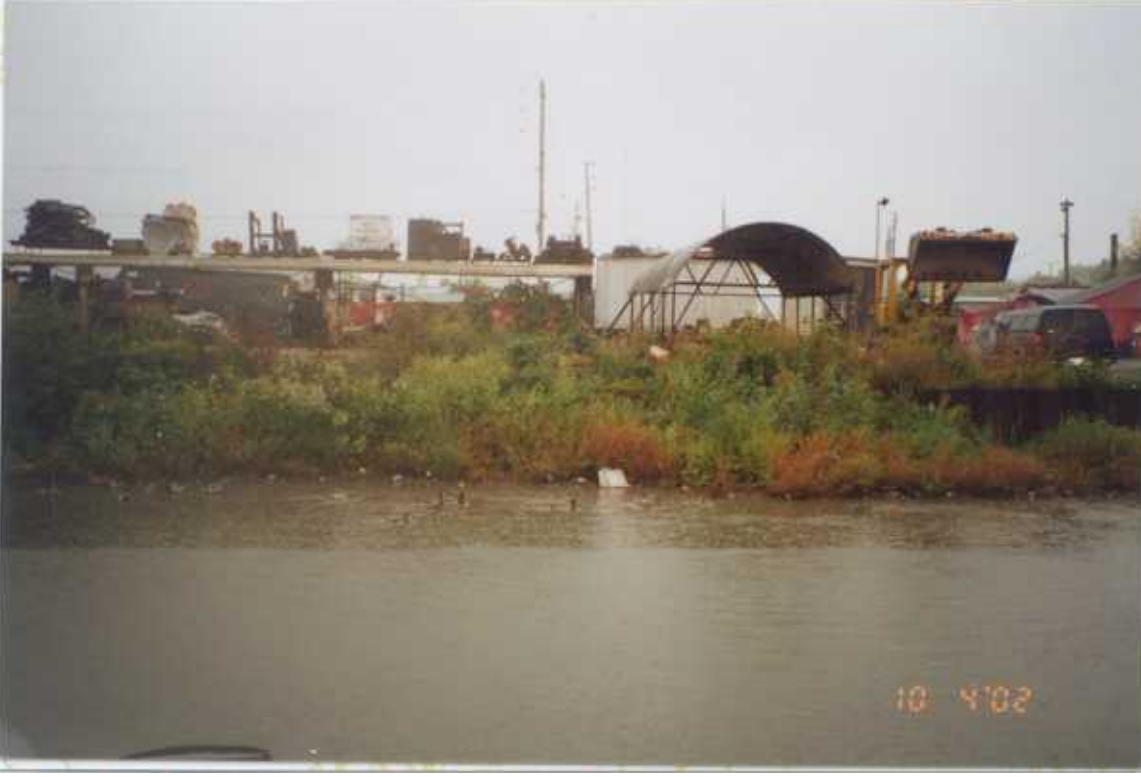
**PHOTO 58 – October 4, 2002 – Kinnickinnic River  
Taken by Tor Hansen, Barr Engineering  
Downstream end of steel sheet pile wall at Parcel 433 and start of  
vegetation along Parcel 436. Looking south.**

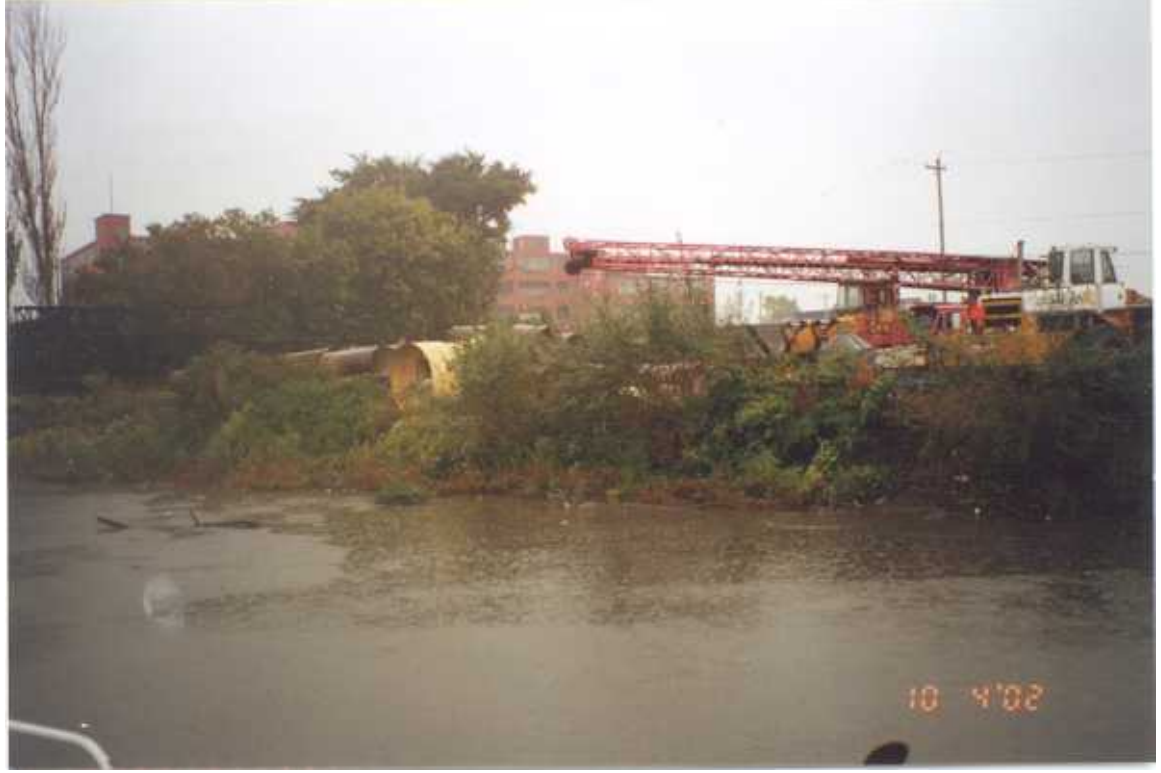
PHOTO 59 – October 4, 2002 – Kinnickinnic River  
Taken by Tor Hansen, Barr Engineering  
Vegetation at shoreline along Parcel 436. Looking south.

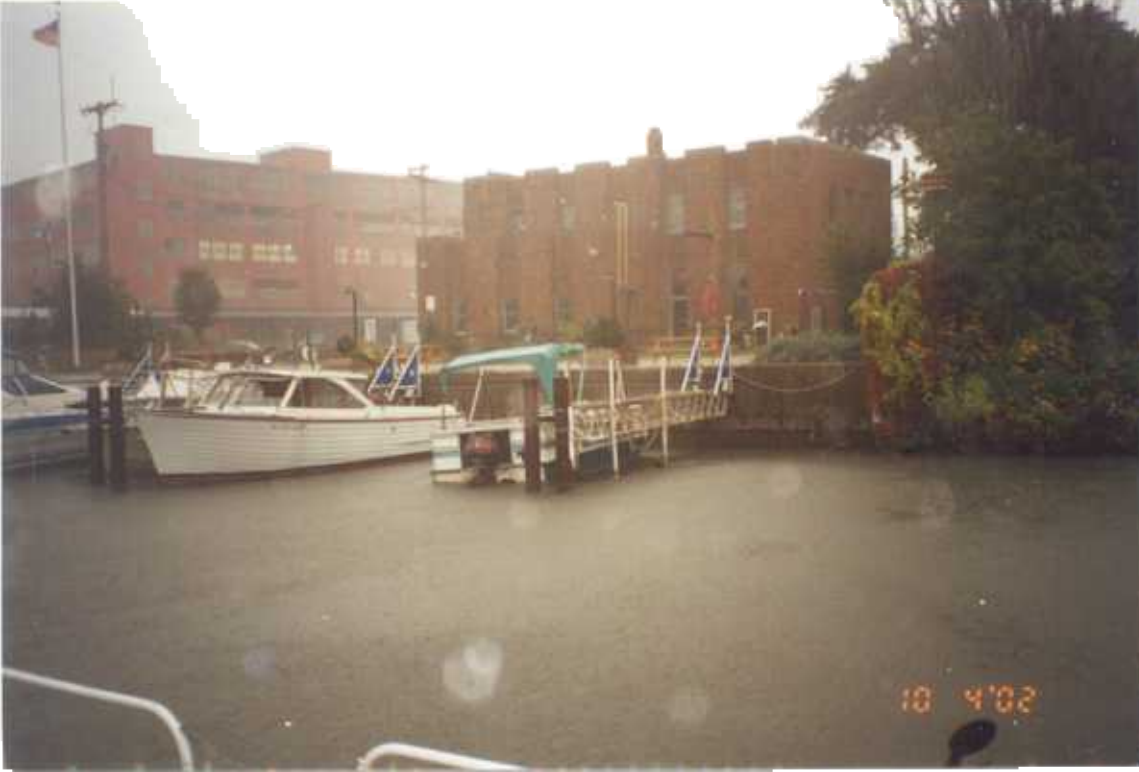
PHOTO 62 – October 4, 2002 – Kinnickinnic River  
Taken by Tor Hansen, Barr Engineering  
Upstream end of concrete wall at Parcel 437. Looking south.

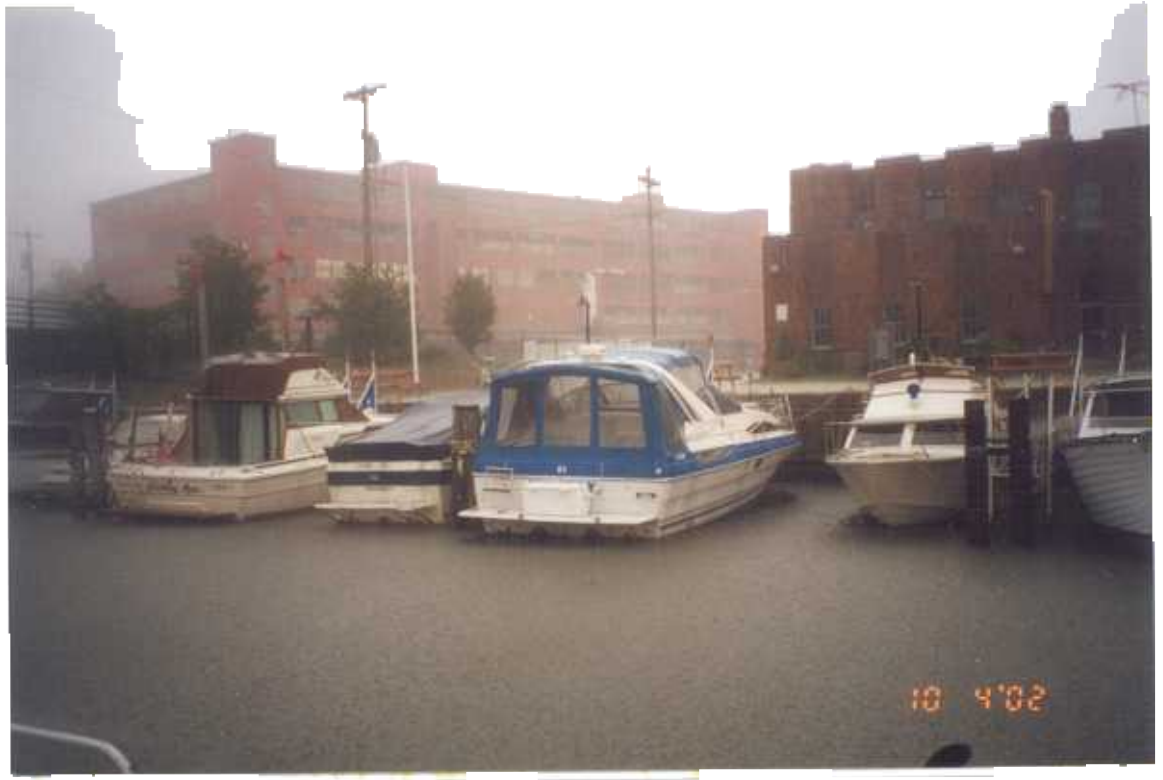
PHOTO 64 – October 4, 2002 – Kinnickinnic River  
Taken by Tor Hansen, Barr Engineering  
Upstream face of right abutment of 1<sup>st</sup> Street Bridge. Looking  
southeast.

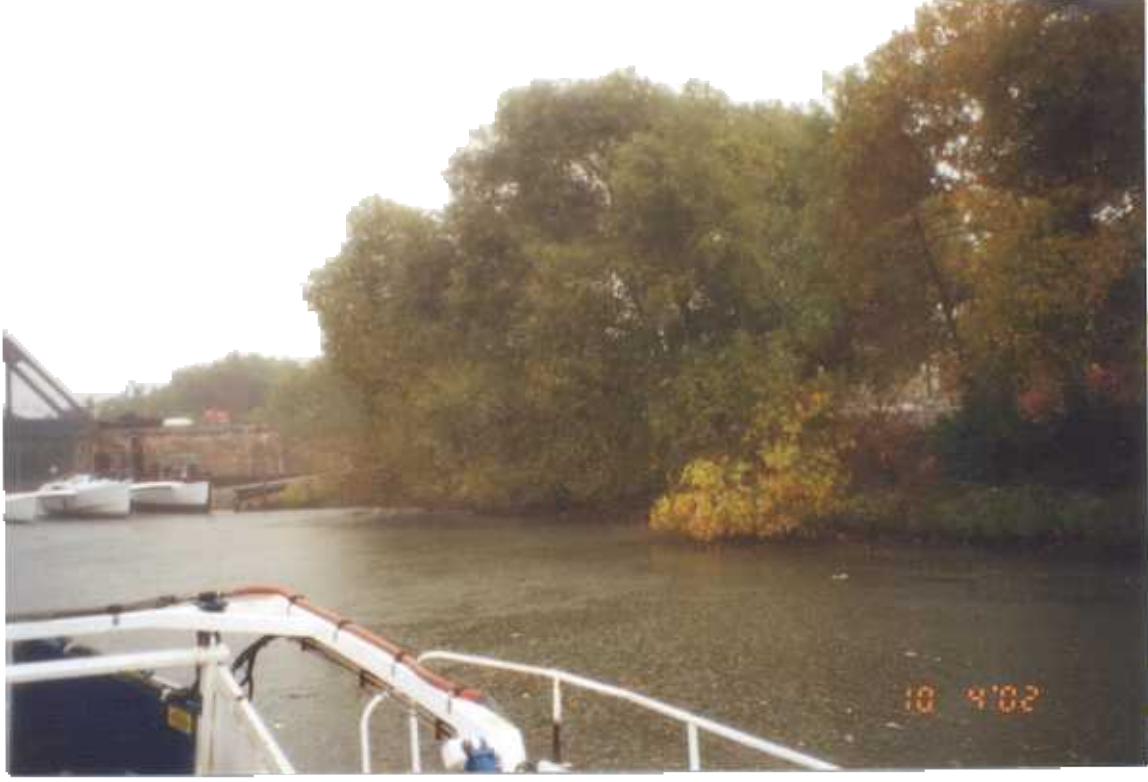
PHOTO 66 – October 4, 2002 – Kinnickinnic River  
Taken by Tor Hansen, Barr Engineering  
Vegetation along Parcel 439. Looking southeast.

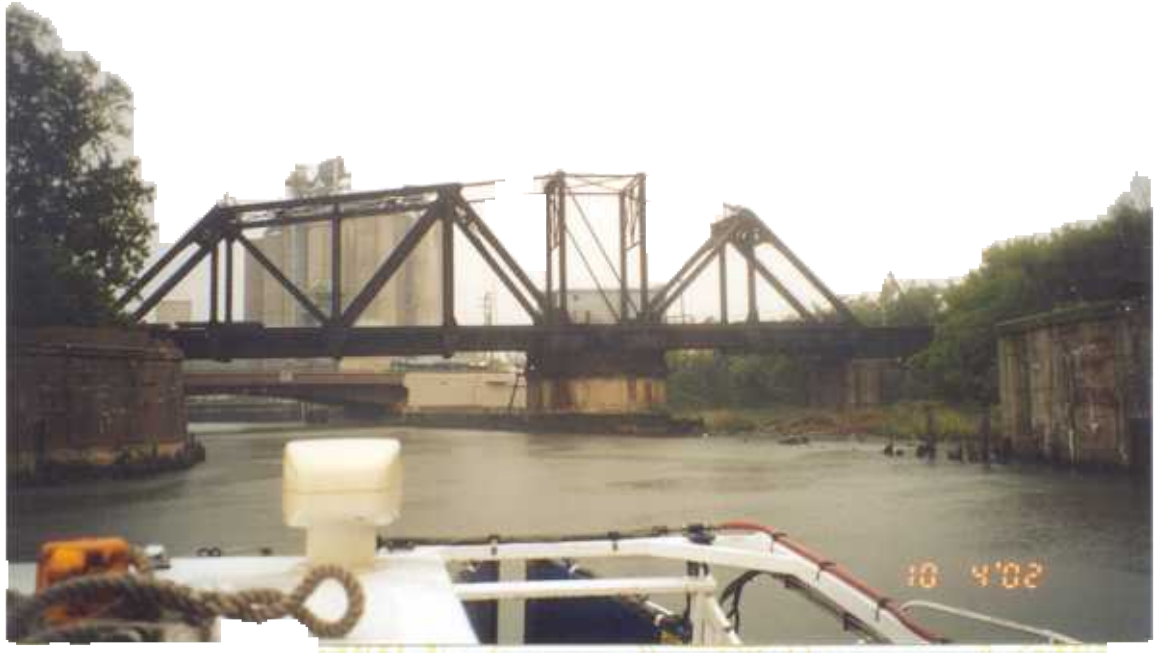
**PHOTO 68 – October 4, 2002 – Kinnickinnic River**  
Taken by Tor Hansen, Barr Engineering  
New steel sheet pile construction adjacent to old bridge abutment  
at Parcel 440. Looking south.
